Case Study: Torsional Vibration Assessment and Mitigation

AP Dynamics Inc.

Abstract

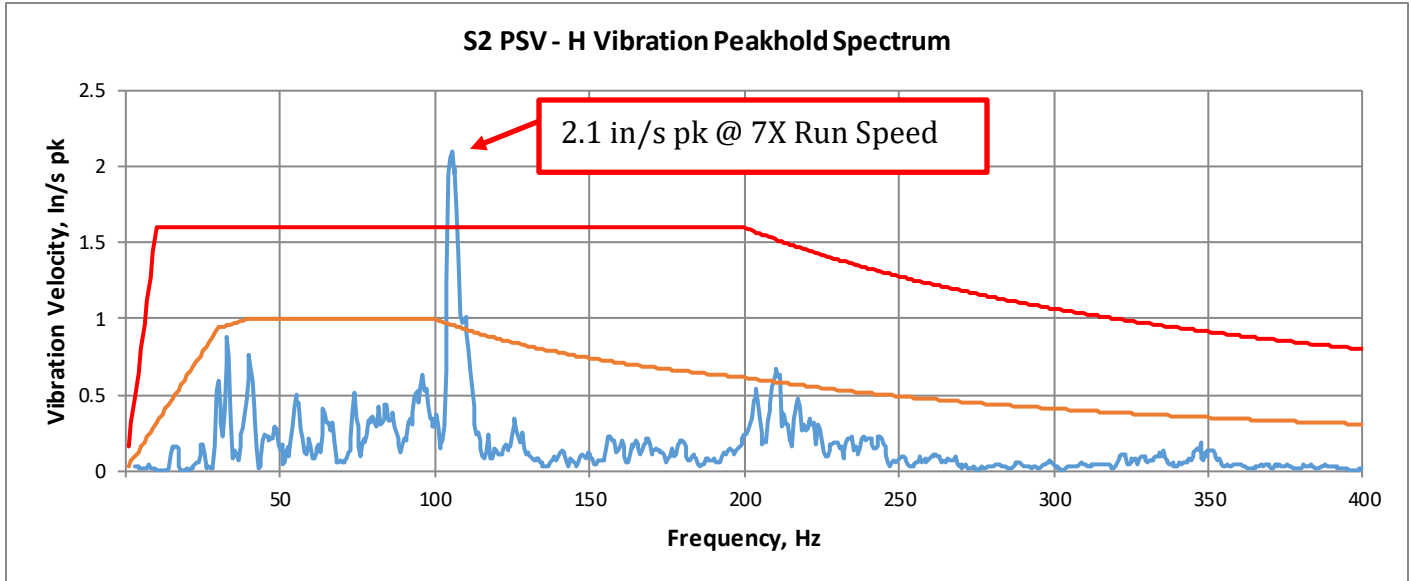
Several areas were determined to experience mechanical resonance, at either 1X or 2X run speed which is not unusual for reciprocating compressor packages. Other areas, however, exhibited an above-guideline 7X vibration that was not consistent with signs of potential resonance or elevated pressure pulsation issues. Moreover, the direction of vibration was not consistent, meaning that it was neither parallel to the flow or perpendicular to it. It was varying in direction among locations.

Figure 1: Example of 7X Vibration Measured on Site

At the time of the site visit there were no accessible ports on the process piping to be able to take pressure pulsation readings. Although these readings were not available, the data gathered and our initial analysis showed that pressure pulsation was unlikely the cause, because of the odd multiple of vibration (typically only even orders appear in a double-acting unit) and the varying directions of vibration that had no correlation with the direction of flow. Although there was no clear indication of a problem, AP Dynamics wanted to confirm that pressure pulsation-related issues were not causing this vibration and recommended that an acoustical study is performed.

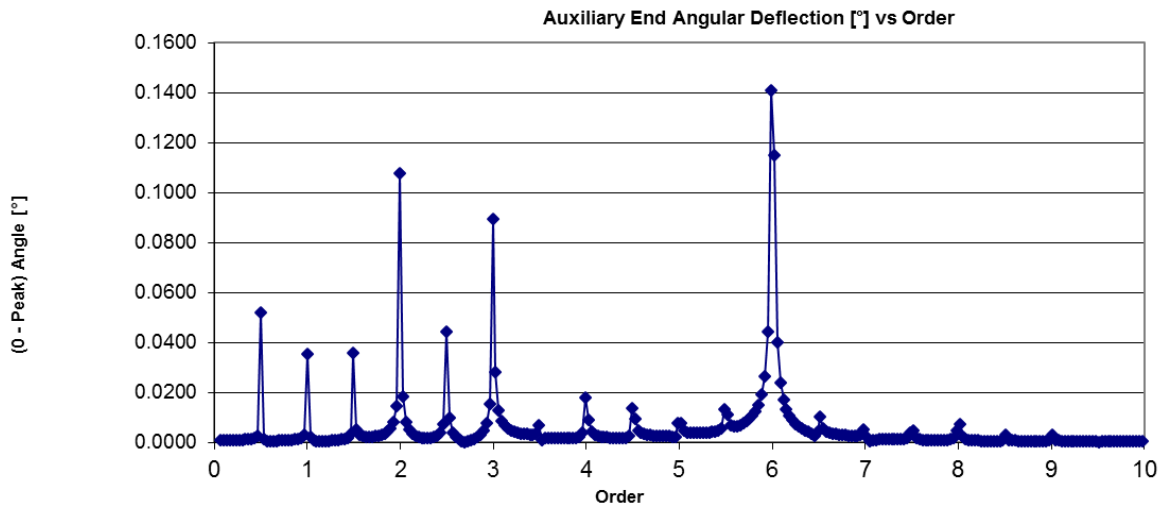
Following the acoustical study, AP Dynamics conducted a torsional analysis of both compressor units. The analysis found that the 2nd torsional natural frequency (TNF) lined up with the 6th harmonic of the compressor run speed, resulting in high angular deflection of the crankshaft.

Figure 2: Predicted Angular Deflection on Auxiliary End of Compressor Frame Crankshaft

Studies conducted by Ariel (Newman et al., 2012) have shown that lateral vibration stemming from torsional vibration occurs at side band frequencies of the torsional oscillation, not at the same frequency as the torsional vibration. By this account the 6X torsional vibration occurring in the crankshaft could be correlated to the 7X lateral vibration seen throughout the package. This is termed lateral-torsional vibration coupling.

Working closely with Ariel, AP Dynamics came up with two possible solutions to mitigate the 6th order vibration within the crankshaft:

1. Shift the 2nd TNF out of the resonance range of any 6th harmonic by means of detuning, using an internal flywheel on the auxiliary end of the compressor.
2. Reducing the torsional vibration by means of an active internal damper installed on the auxiliary end of the compressor crankshaft.

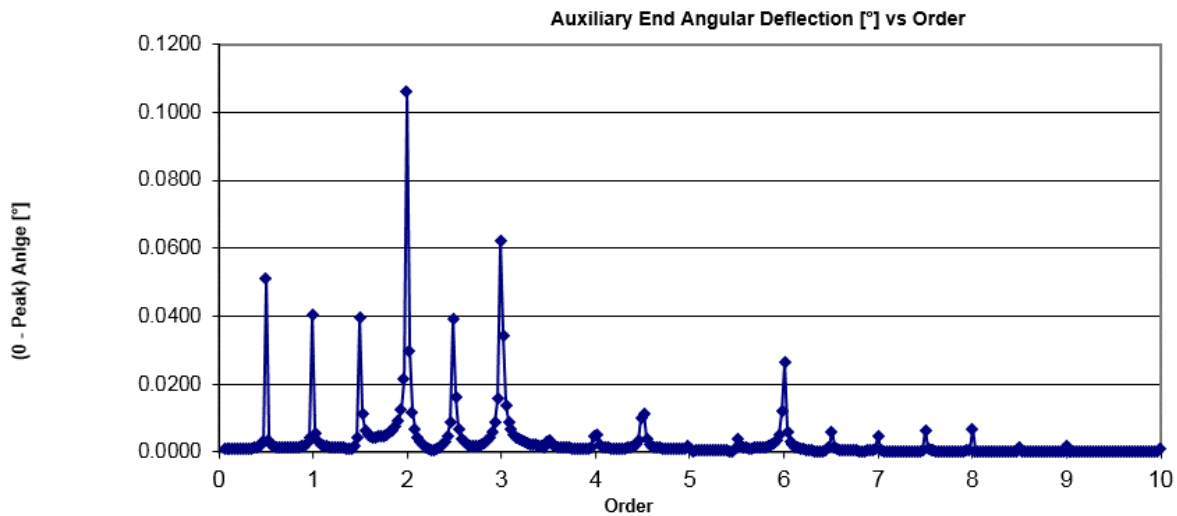
Forced response analysis showed a very significant reduction in torsional vibration at the 6th harmonic when the internal damper (Option 2) on the auxiliary end of the compressor was used. The torsional analysis also showed the system passing the following requirements and criteria:

Figure 3: Predicted Angular Deflection on Auxiliary End of Compressor Crankshaft with Internal Damper (D7580)

As a result of the analysis and discussions with Ariel, AP Dynamics concluded that the Ariel D7580 torsional damper installed on the internal auxiliary end of the compressor crankshaft would be the most effective alternative to reduce the vibration seen at the 6th harmonic. This solution was brought forth to the client as a method to reduce vibration levels throughout the packages.

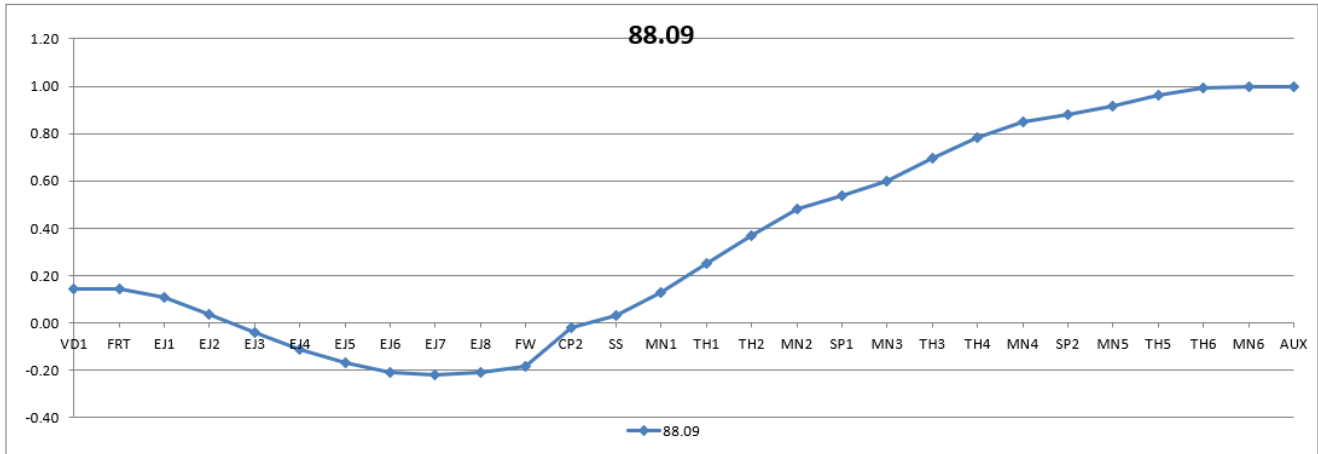
One has to be aware of torsional deflection nodes that vary per mode shape. Nodes are defined as points along the crankshaft that undergo zero deflection at a given mode shape. As an illustration for the 2nd mode shape in this application a node can be seen at CP2 (coupling) location in Figure 5. It is important to consider the results of the torsional analysis when validating it by conducting the torsional vibration survey. It should be used to help ensure that the location selected for measurement does not fall on a node. Taking this into account, measurements performed on either end of the compressor will typically give representative results. By referring to Figure 5 below, we can see that the auxiliary end is an anti-node for the 2nd torsional natural frequency.

Figure 5: 2nd Torsional Mode Shape

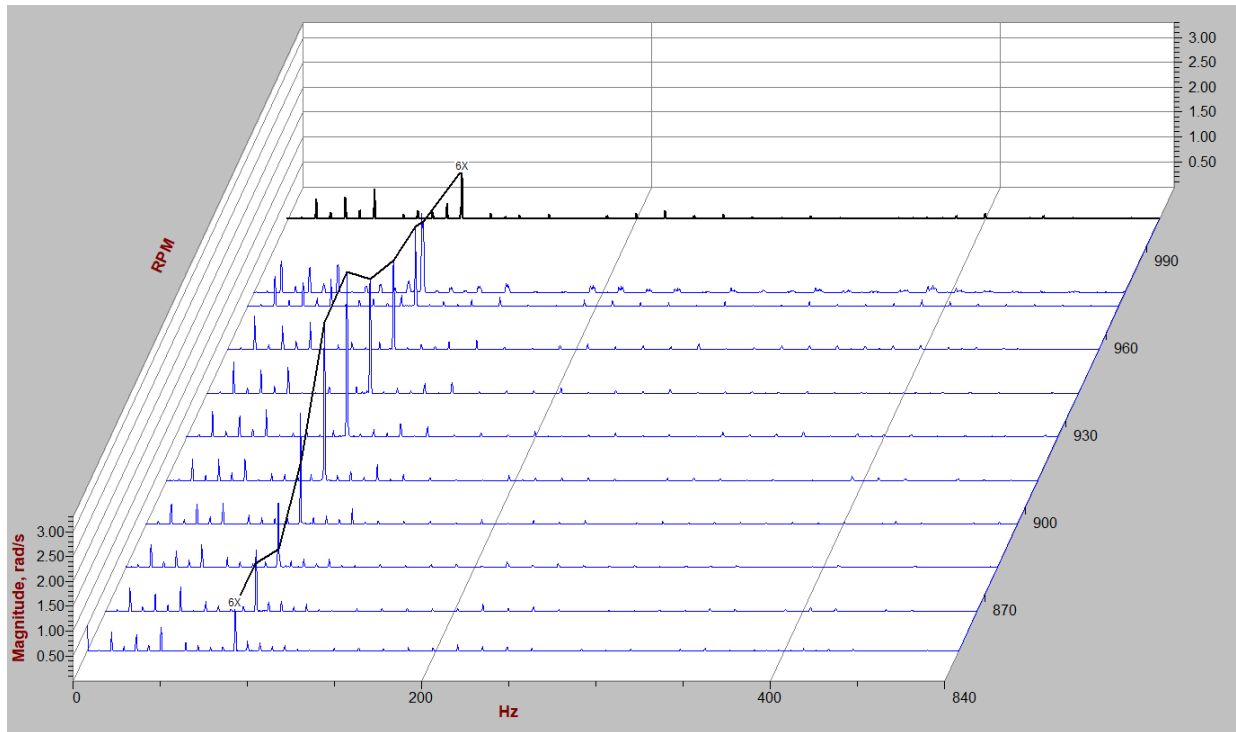
Figure 6: Torsional Survey Plot

The plot showed that the dominant frequency was found to be 6X the run speed. This validated the results of the torsional analysis performed prior to the survey and confirmed the suspicion of a lateral-torsional vibration coupling.

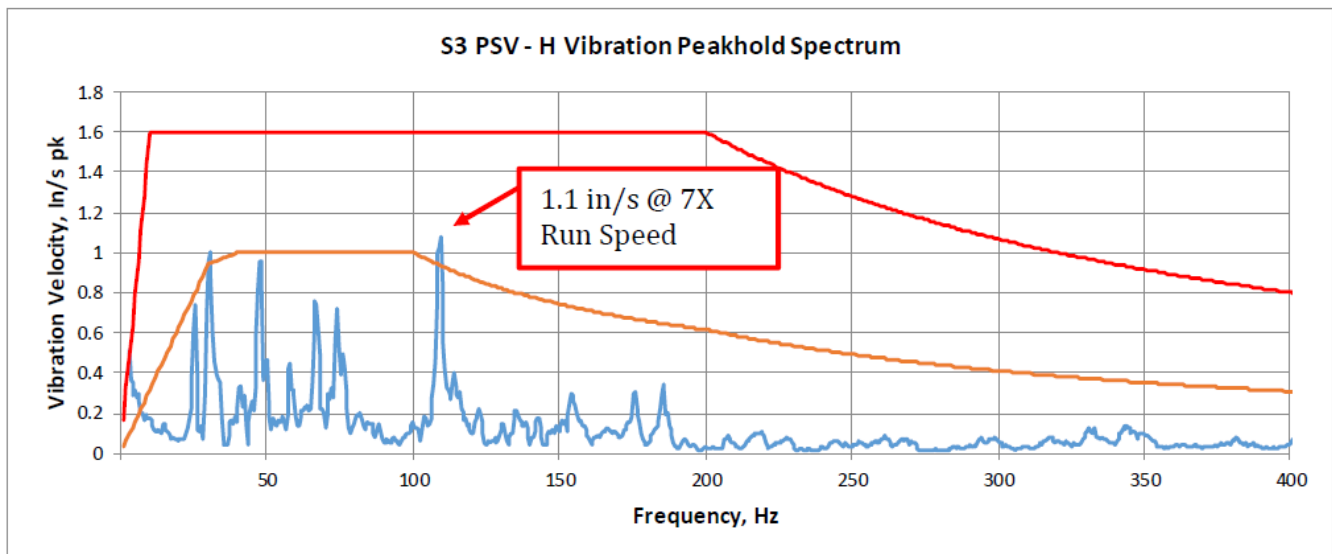
The results from the survey showed drastic improvements in 7X vibration where the vibration levels were greatly reduced after the damper was installed. A comparison of the vibration occurring on Stage 3 Discharge PSV before and after the damper was installed can be seen in Figure 8 and Figure 9, respectively. Table 1 shows three locations that had the biggest improvements in vibration levels at 7X vibration.

Figure 8: 7X Vibration Prior to the Installation of the Internal Damper - 7X at 940 RPM

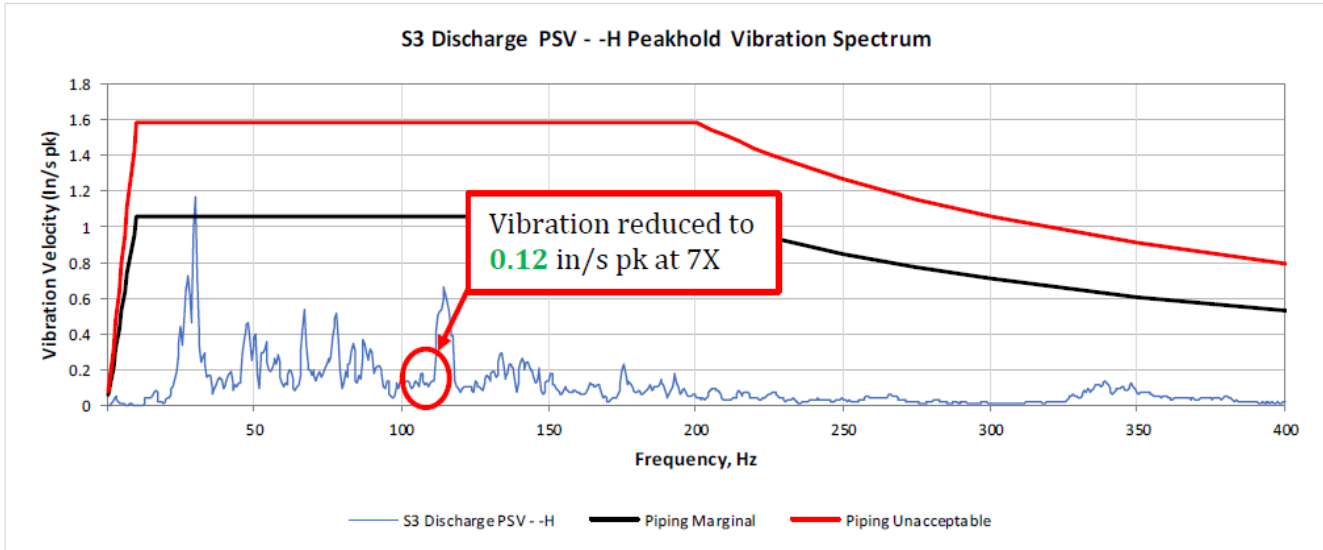
Figure 9: 7X Vibration After the Installation of the Internal Damper – 7X at 940 RPM

Once the modification was reviewed and approved by Ariel, the client proceeded with the installation of the damper in one of the units. This unit was the worst of the two in terms of vibration.
