Case Study: Torsional Vibration Assessment and Mitigation

AP Dynamics Inc.

Abstract

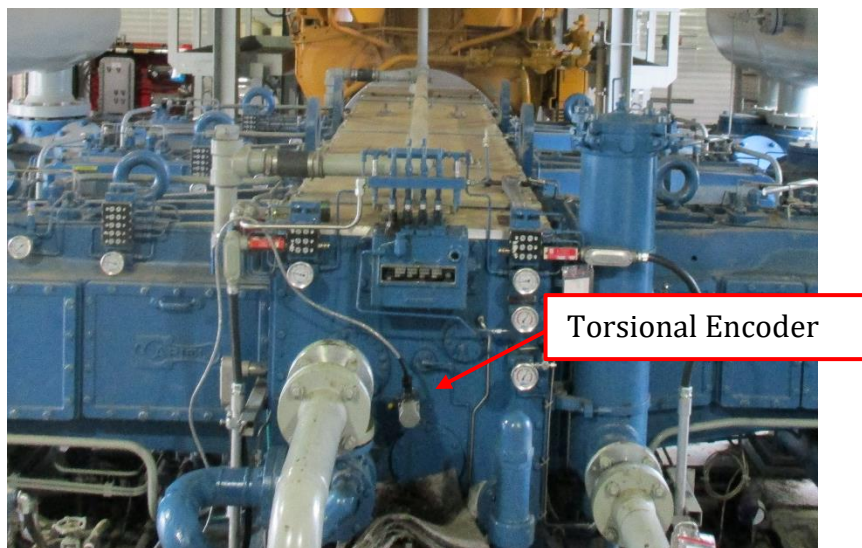
Figure 4: Torsional Encoder Installation on Auxiliary End of Compressor Frame

A custom designed torsional encoder was used. The encoder was designed and built in-house. This piece of hardware allows AP Dynamics to directly connect to the crankshaft of an Ariel compressor frame on the auxiliary end through an access port on the frame and is designed to work with most Ariel stock models. The system is designed in such a way to minimize compressor downtime required for installation and removal. It takes approximately 30 minutes of downtime to install, compared to the roughly 2 hours required for strain gauges. Additionally, it works together with tachometers to directly correlate vibration with the RPM of the unit.

The plot showed that the dominant frequency was found to be 6X the run speed. This validated the results of the torsional analysis performed prior to the survey and confirmed the suspicion of a lateral-torsional vibration coupling.

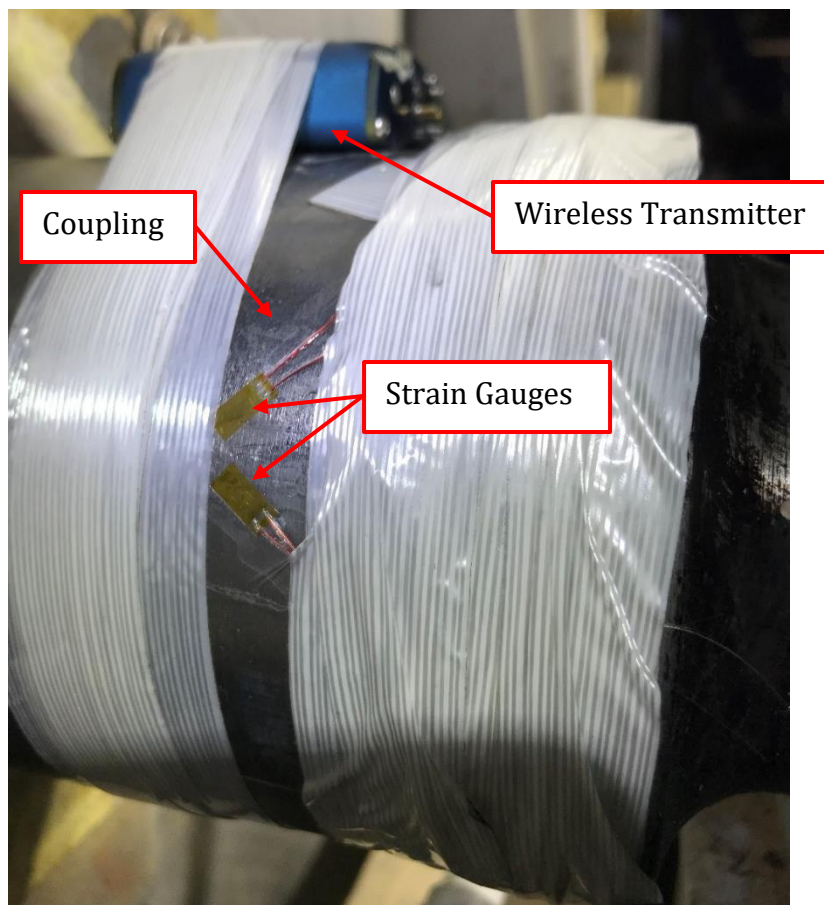
Figure 7: Example of Strain Gauge Installation for Torsional Vibration Measurements on Coupling

A commonly used alternative to the torsional encoder is strain gauges. Unlike the torsional encoder, strain gauges are mounted on the coupling. Both the strain gauges or torsional encoder prove as effective means in capturing torsional vibration, however, installation of strain gauges takes considerably more time due to the requirements of perfectly clean surfaces and a more complex installation procedure. In some cases, and depending on the equipment available, up to 4 strain gauges are required to be adhered to the coupling. Adequate training in installation and wiring is required in order to accurately capture strain gauge data.

The strain gauge signal is read using a wireless system that allows for a safe and robust installation, sometimes without the need to remove the coupling guard during operation.
